EVALUATION OF LUBRICATING COMPOSITES FOR THE M16A1 RIFLE

GEORGE P. MURPHY, JR.
BERNARD J. BORNONG

FEBRUARY 1976

TECHNICAL REPORT

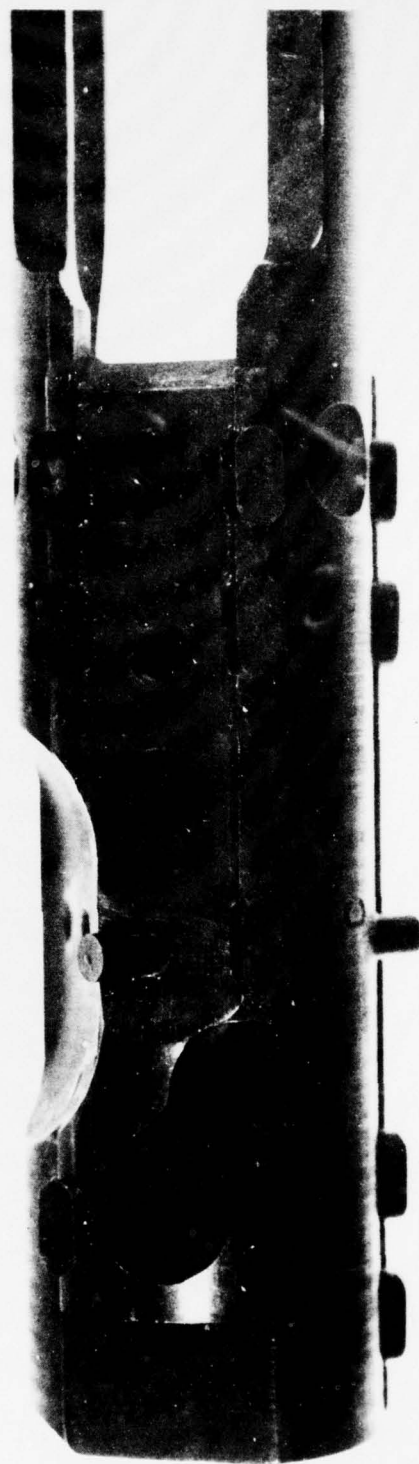
The types of composite inserts used are shown in Figure 4. These inserts were glued in place with epoxy resin, as shown in Figures 5 and 6. The composite inserts were then ground down until they protruded .005 inch above the surfaces to which they were applied. The appearance of the bolt carriers after this grinding process is shown in Figures 7 and 8.

Figure 5. Left Side of Bolt Carrier Showing Inserts in Place.

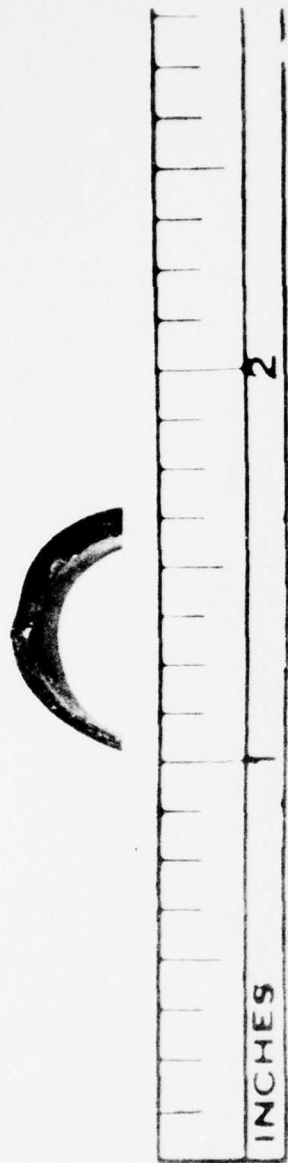
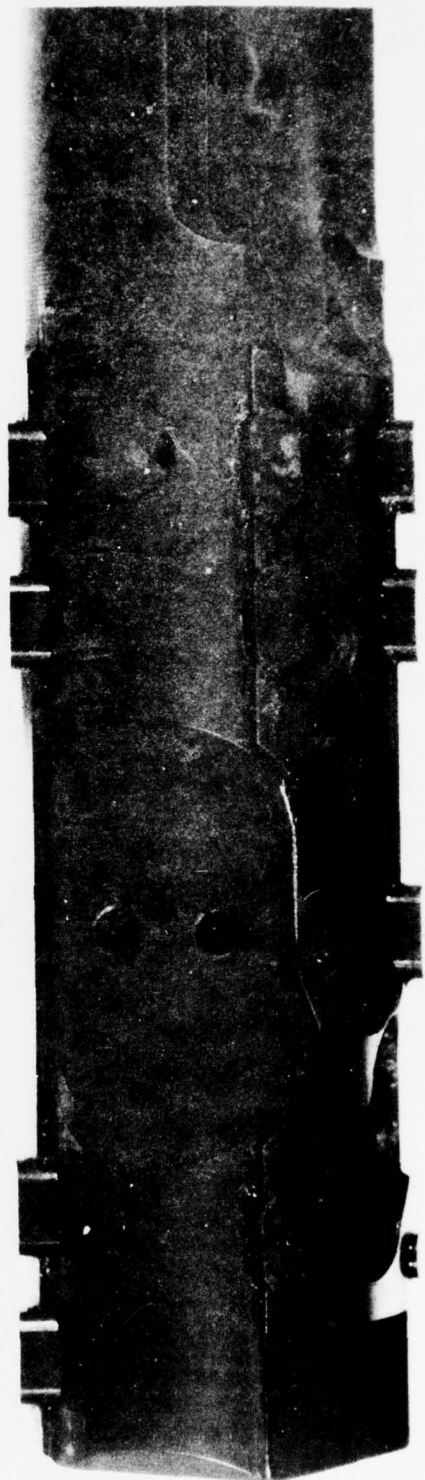
Figure 6. Right Side of Bolt Carrier Showing Inserts in Place.

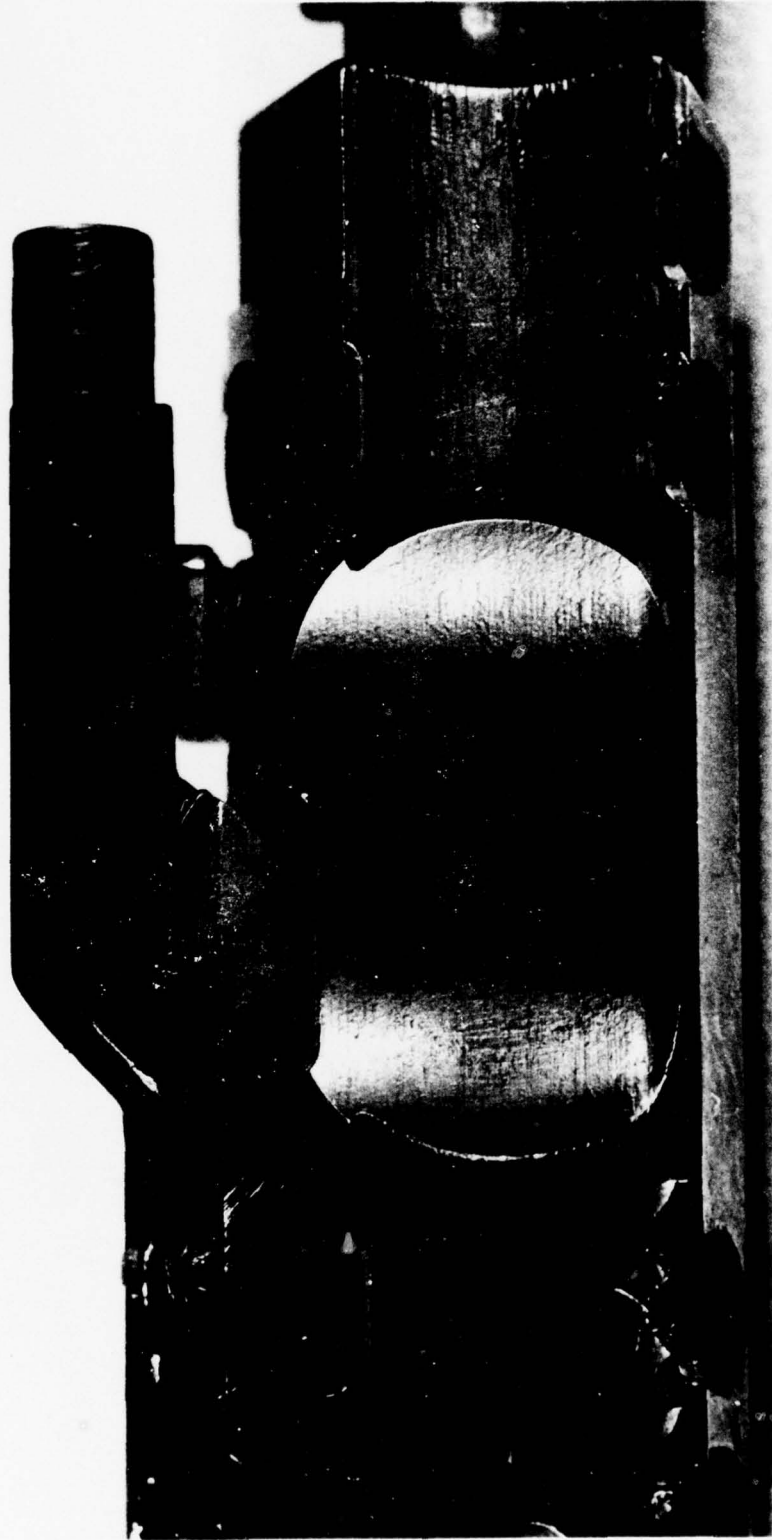
Figure 8. Right Side View of Bolt Carrier With Inserts Ready for Test.

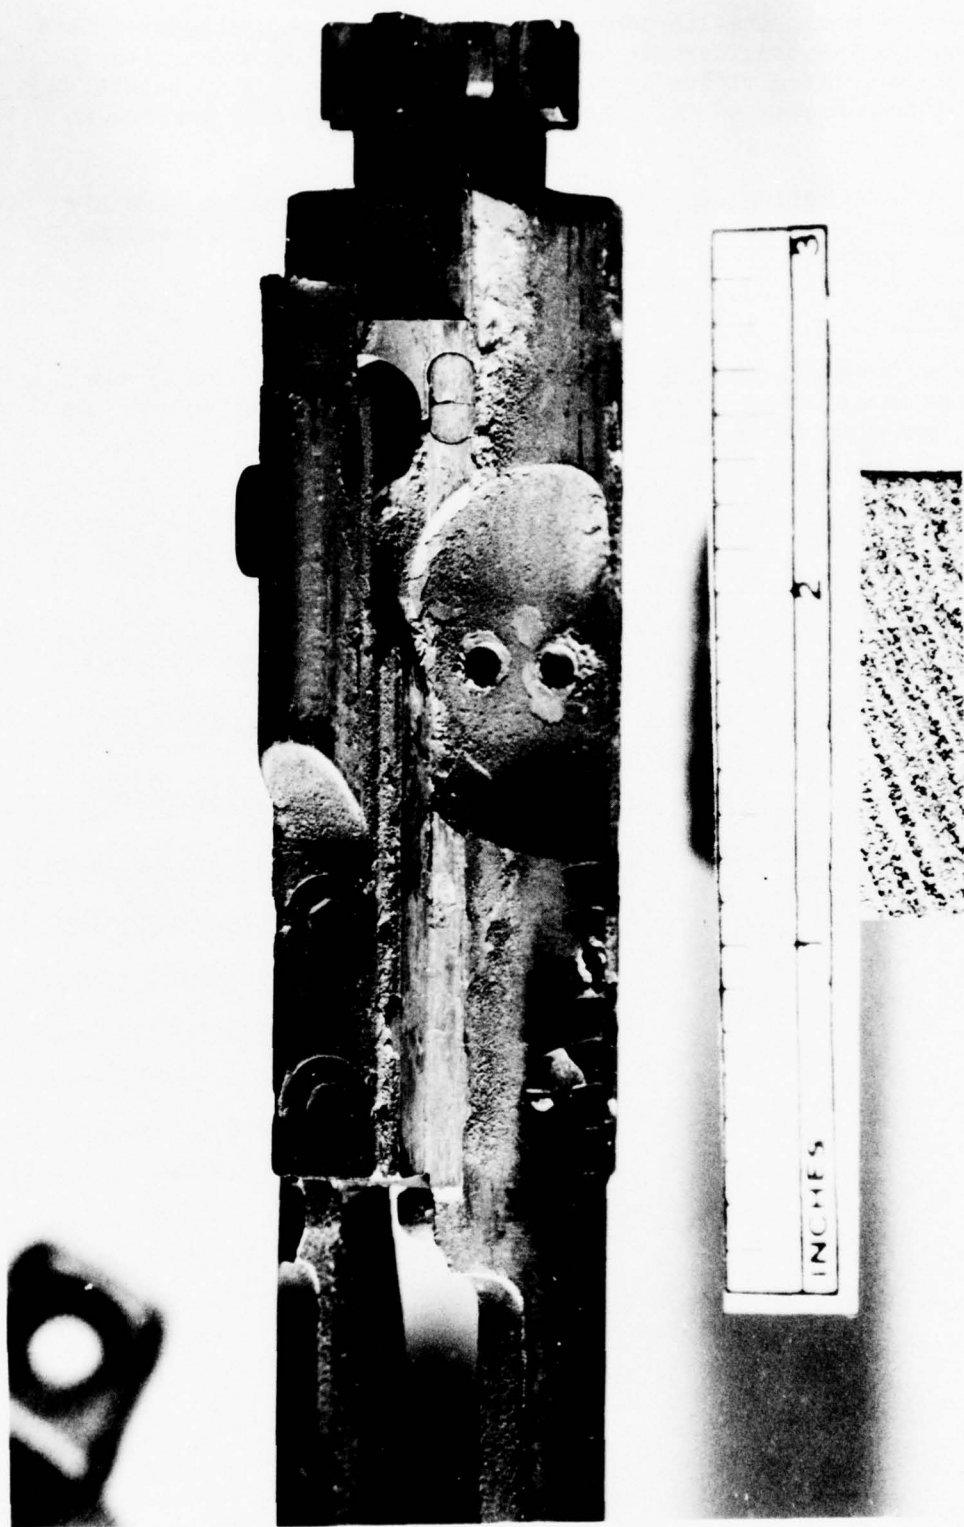
Although Rifles Nos. 2 and 3 completed the 10,000-round test, the composite insert in the cam path area had cracked. In Figure 9, the bolt carrier of Rifle No. 3 is shown at the end of the test with the cracked insert. Therefore, with the exception of Rifle No. 4, which was in the test for only a short time, the composite insert in the cam path area, at which the cam path wall was broken through during machining, either fell out or broke off, or was cracked. The effect of this on the test results is difficult to assess. The exact time at which these inserts cracked could not be determined; however this cracking could have occurred very early in the test. Some malfunctions undoubtedly occurred because of these cracked inserts and not because of any lubrication deficiencies. In spite of the difficulties encountered with the inserts in this one area of the carrier cam, the 6-malfunction rate per composite-lubricated rifle is considered very good.

Figure 9. Bolt Carrier after 10,000 Rounds Showing Cracked Insert.

2. Since the lubricating composite tends to be brittle and susceptible to cracking, care must be exercised in machining the insert holes and in placing the inserts.
